U.S. Coast Guard Marine Safety Office, Portland, Maine

SAFETY ALERT 01-01

Repairs to Steering Gear, Thru-Hull Fittings, & Machinery

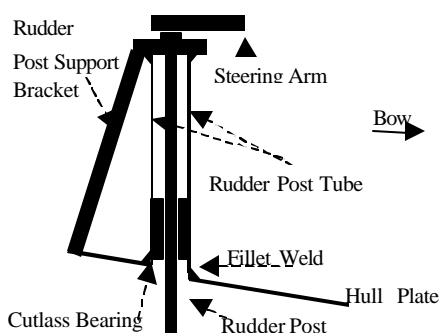
Figure 1, Rudder Port Fitting Before Repair

The year 2000 saw several Maine fishermen die and even more fishing vessels sink, due in part to improper repairs to steering gear, thru-hull fittings, and machinery. In one case, the Coast Guard concluded that flooding began through a failed rudderpost fitting. The rudderpost fitting (see Fig 1) was typical of Gulf of Mexico shrimp fleet vessels built in the early 1960's.

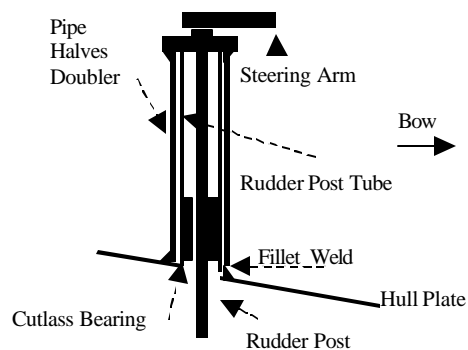
Figure 2, Rudder Port Fitting After Repair

The rudderpost tube was wasted, and the owner conscientiously chose to repair it. Rather than replacing the tube, which would have required drydocking and dropping the rudder, they instead doubled the tube with a piece of pipe sliced and re-welded together around the old tube. In order to fit the pipe halves around the tube, a fillet weld at the base of the old tube was ground off, and channel brackets supporting the fitting were removed. The new pipe halves did not fit snugly around the old tube. Keeping in mind the cutlass bearing inside the old tube, the welds that were ground away were critical to support the rudderpost. Also, when the repair was completed, only two of the three rudderpost support brackets were re-installed. Finally, a new hydraulic control system was added to provide more power to the steering control system, which greatly added load on the rudder port fitting.

This repair likely weakened the overall fitting. Though it may seem intuitive that adding metal to a structure would add strength, this is only true when stresses remain balanced. In this case, stresses were redistributed, concentrated, and therefore, multiplied at critical points in the fittings.

After grinding the weld where the old tube connected to the hull, the cutlass bearing was no longer well supported and the weld probably cracked. The gap between the pipe halves and the old tube was relatively small, creating weld discontinuities as the pipe halves were welded together. This small gap allowed the new tube to be intermittently welded to the old tube with intermittent burn-throughs at thin areas of the old tube. Most likely, both of these defects occurred randomly as the weld was laid down and the old and new rudder tubes were unintentionally welded together. This created a lever,

multiplying the stress at the weld where the pipe halves were jointed to the hull. The welding process adds a great deal of heat to a small area, which without stress relief traps the stresses. Cracks commonly result from these conditions, as all the stresses are concentrated at the weld discontinuities.

Not reattaching the fore and aft rudderpost support bracket also weakened the overall structure. Additionally, the load on the fitting was increased substantially by the new hydraulic package. The combination of a weaker structure, and a more powerful control system, would have easily in time, overworked the rudder post fitting, breaking it free from the hull and producing a hole as large as six square inches.

These tragedies indicate the need to properly assess the condition of all vital assemblies on a vessel. If a repair cannot be made in kind, a qualified engineer should be consulted to determine if the modifications will properly distribute and withstand stresses. Proper welding procedure and stress relief are essential to minimizing trapped-in stresses. Before adding powered controls to any system, the structure of that system must be evaluated and augmented to withstand the new loads, and must also be considered whenever any modifications are contemplated for other heavily loaded systems, including fishing gear, engine beds, stuffing boxes, machinery mounts, shaft bearings, etc. When in doubt, consult an engineer or a Coast Guard Commercial Fishing Vessel Examiner.
